# National Transportation Safety Board

## Marine Accident Brief

### Grounding and Sinking of Towing Vessel *Stephen L. Colby*

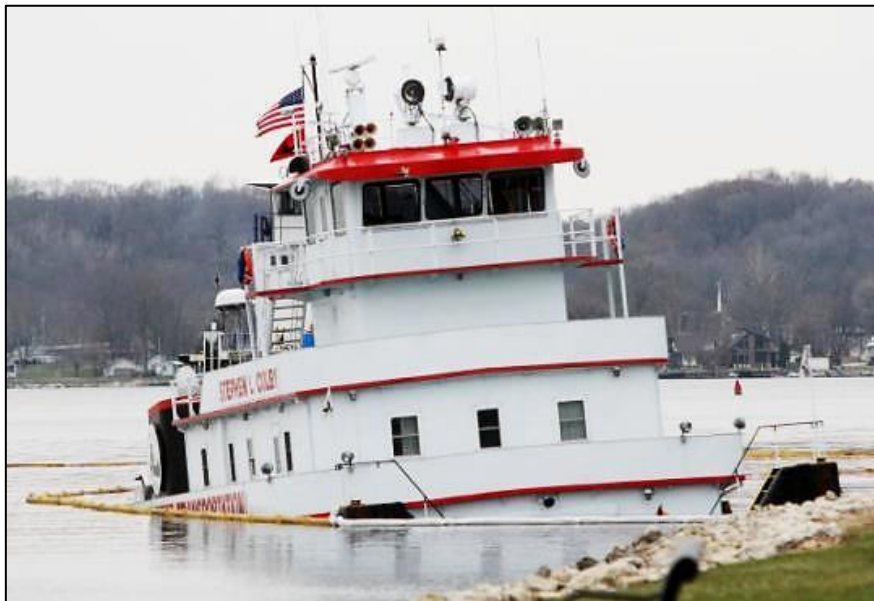
The superstructure of the *Stephen L. Colby* remained above the waterline when the vessel came to rest on the Mississippi River bottom near LeClaire, Iowa. (Photo from Quad Cities Times)

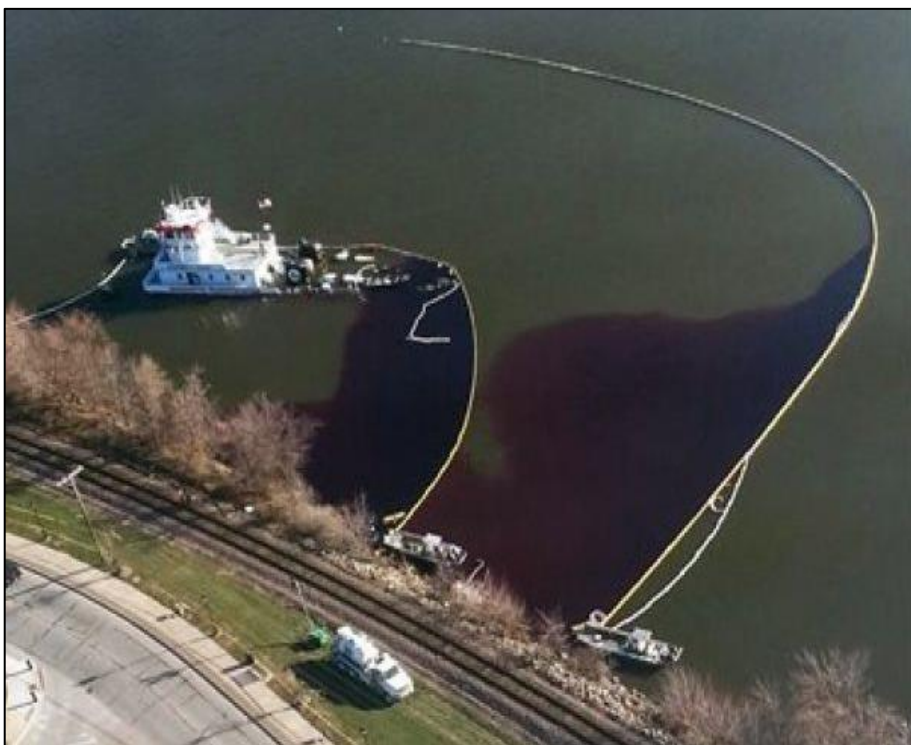
The *Stephen L. Colby* in the days after the sinking, with oil boom deployed to capture petroleum product released from the vessel. (Photo from US Fish and Wildlife Service)

Oil response and salvage operations continued for about 2 weeks after the accident. Salvage divers performed temporary repairs to the hull in the engine room, where an opening about 34 x 30 inches was found just port of the centerline. Divers also completed temporary repairs to a smaller fracture in the hull plate in the pump room and sealed a preexisting fracture in a forward ballast tank. On December 11, 2013, the vessel was towed to dry dock in St. Louis, Missouri, where it arrived December 17 for further repairs.

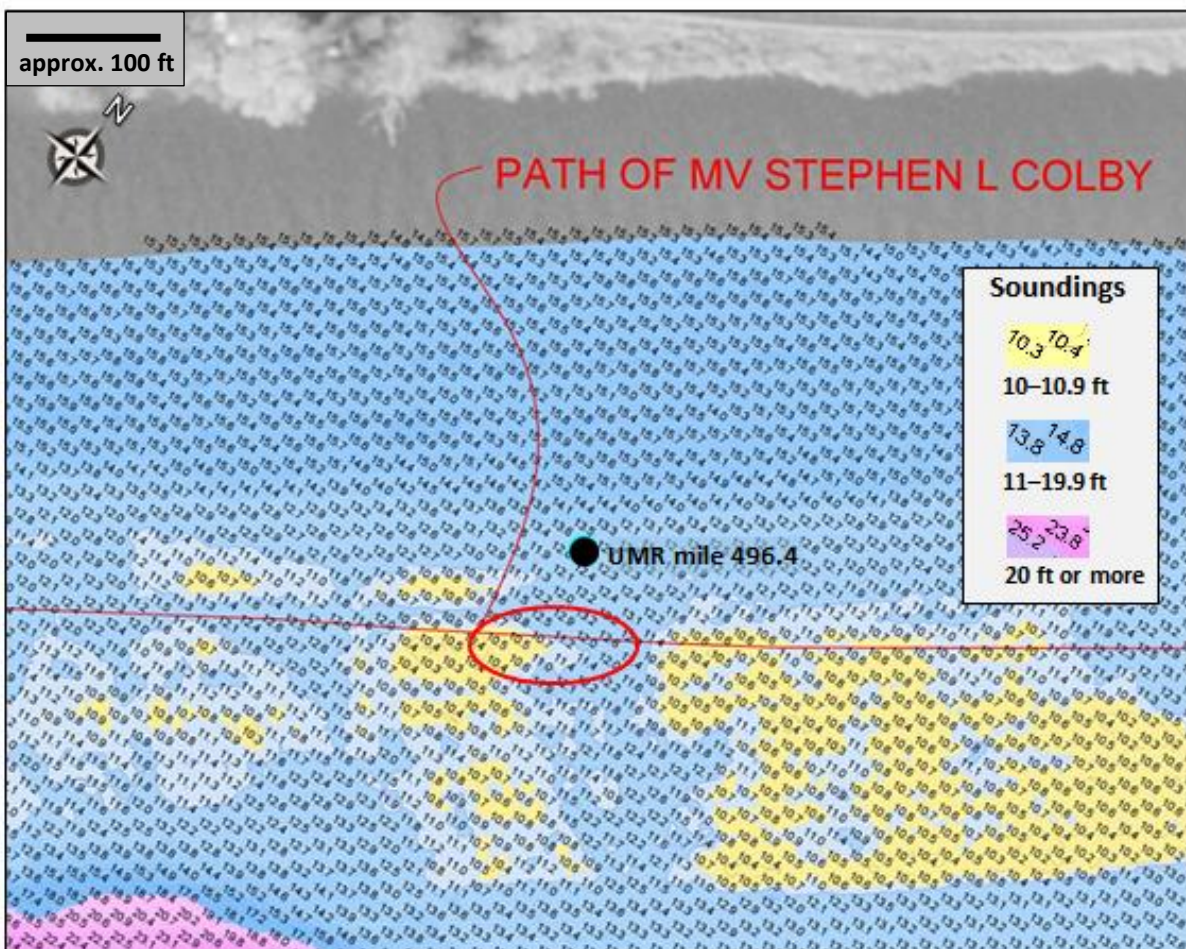
The vessel's course passed over an area where a water diversion dike existed from the 1800s until the mid-1930s, when the channel was modified to accommodate construction of the present Lock & Dam 14.

The shallowest water depth recorded along the vessel's path at the time of the survey was 10.4 feet. Correction to reflect the water level at the time of the accident resulted in a calculated depth of 9.9 feet. According to Coast Guard information, Marquette Transportation reported the draft of the *Stephen L. Colby* at the time of the accident to be 9 feet both forward and aft, leaving an underkeel clearance of 8 to 11 inches

when the *Stephen L. Colby* was at idle speed. Although the squat effect was not calculated in this situation, this hydrodynamic phenomenon—caused when a vessel passes through shallow water at speed—very likely reduced the vessel's underkeel clearance even further. (See box on squat, next page.)

Investigators used AIS data from the *Stephen L. Colby* to determine the vessel's course through the channel. The northeast path of the towing vessel (red line running left to right) is overlaid on a chart of depth soundings taken the day after the accident. The red oval indicates the approximate site of the accident. (Data plot by Coast Guard)
