# National Transportation Safety Board

## Marine Accident Brief

### Grounding and Sinking of Towing Vessel *Stephen L. Colby*

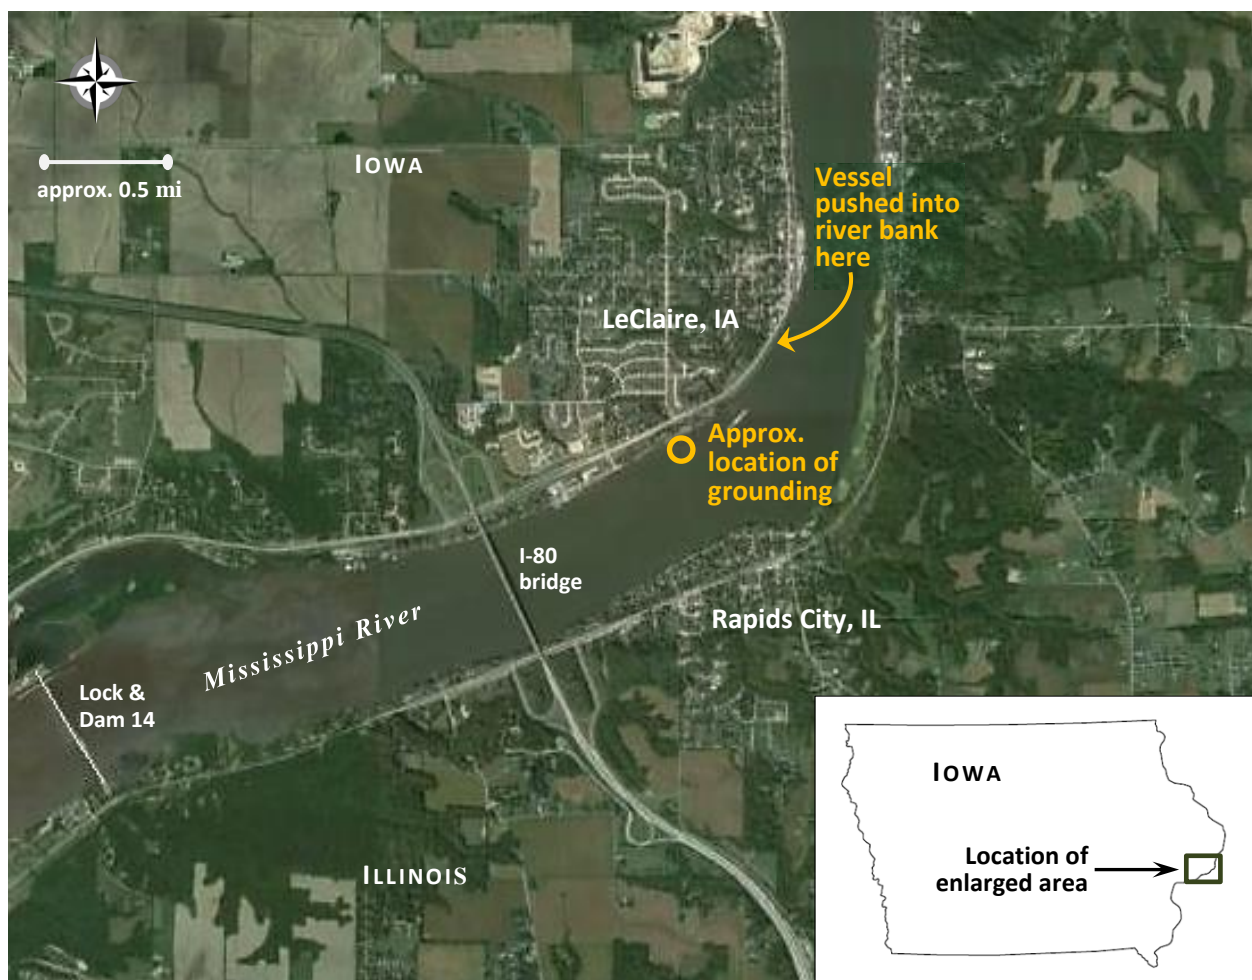
Location of the grounding and sinking of the towing vessel *Stephen L. Colby*. (Background by Google Earth)

The USACE conducted soundings and a side-scanning sonar survey of the waterway near the accident site but did not locate any unknown hazards or obstructions on the river bottom. Using automatic identification system (AIS) data obtained from the *Stephen L. Colby*, the USACE overlaid the vessel's trackline on the sounding results. The results indicated the vessel had remained within the navigable channel before the accident (see below).
